Appendix A

Cultural Resources Survey Reports

**PHASE IB CULTURAL RESOURCES SURVEY
OLD ROOSEVELT FIELD
GROUNDWATER CONTAMINATION SITE
VILLAGE OF GARDEN CITY AND
TOWN OF HEMPSTEAD, NASSAU COUNTY
NEW YORK**

**Phase IB Cultural Resources Survey
Old Roosevelt Field
Groundwater Contamination Site
Village of Garden City and
Town of Hempstead, Nassau County
New York**

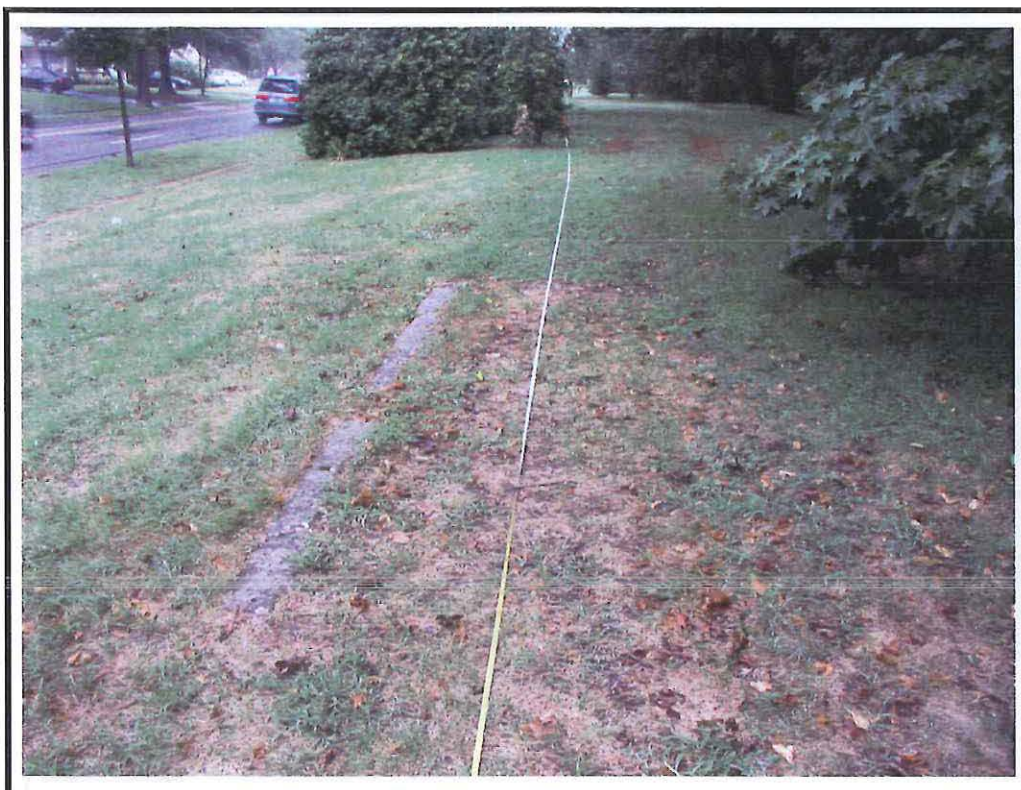
Concrete foundation remnant between STPs 12 and 13.

Photograph 22: Concrete foundation remnant between STPs 12 and 13.

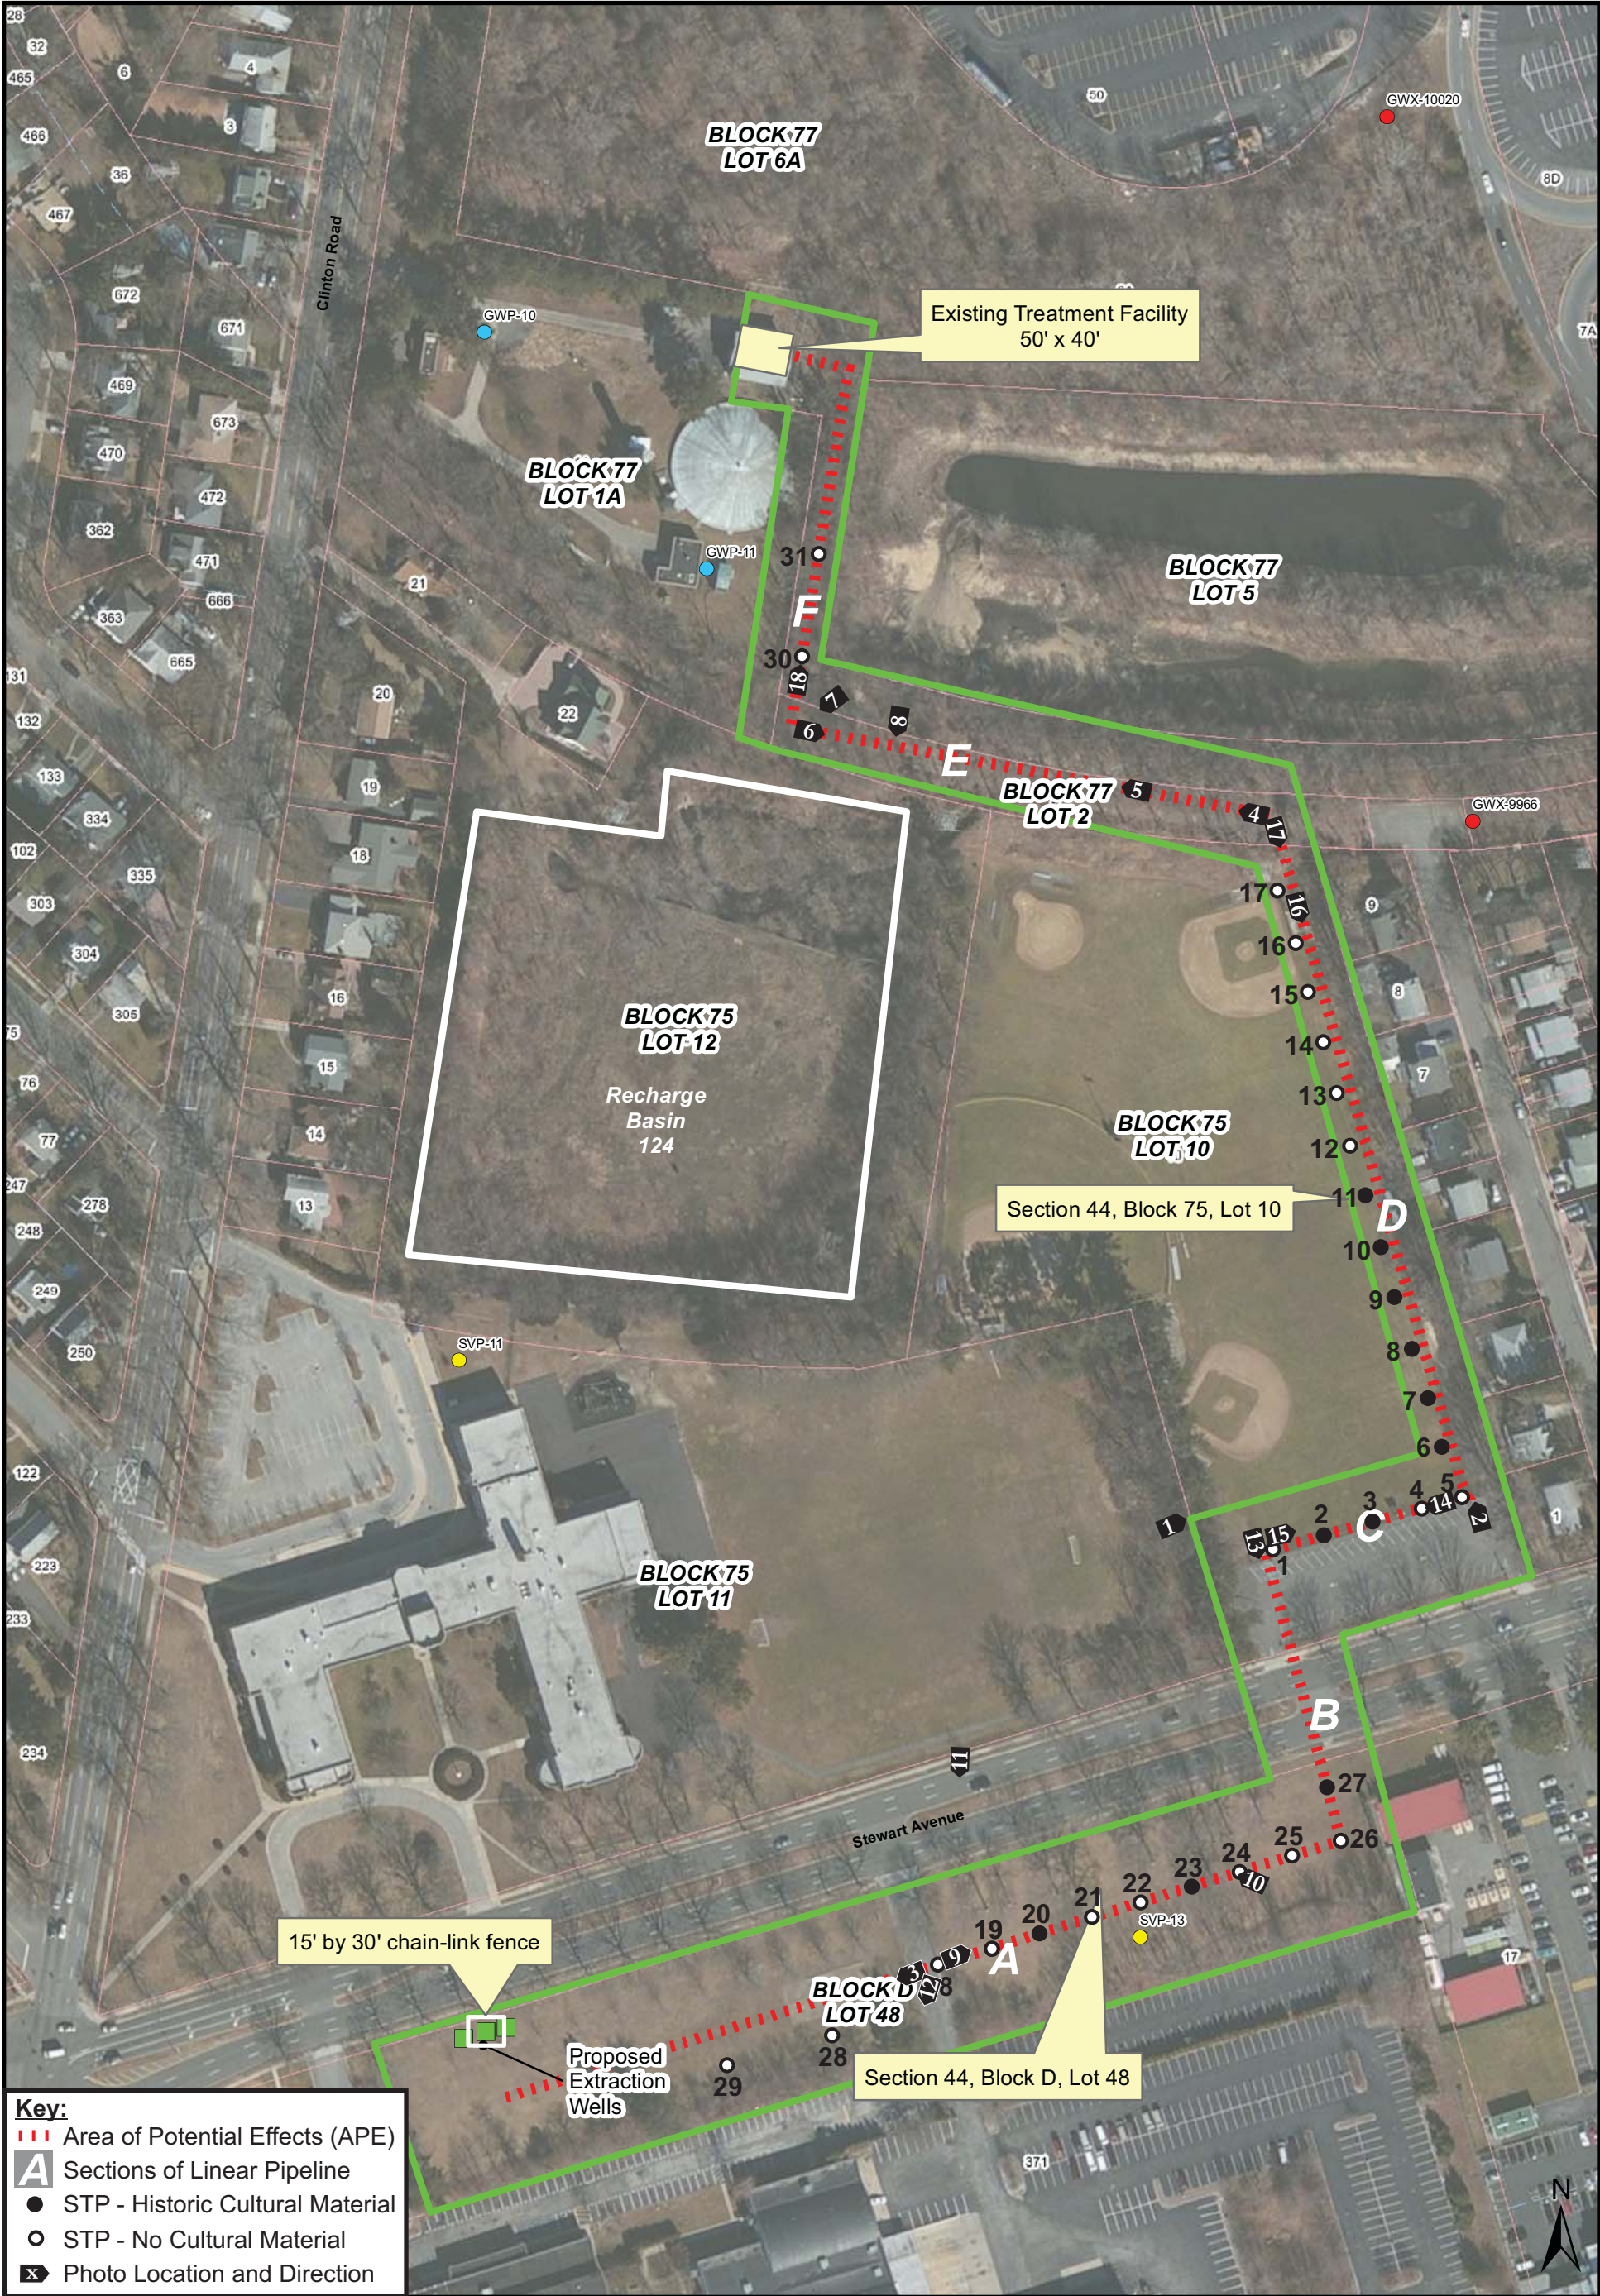
Key:
--- Area of Potential Effects (APE)
A Sections of Linear Pipeline
● STP - Historic Cultural Material
○ STP - No Cultural Material
x Photo Location and Direction

Figure 2: Aerial map showing the location of the APE, shovel test pits, and photographs.

The APE is defined in 36 CFR 800.16(d) as “the geographic area or areas within which an undertaking may directly or indirectly cause changes in the character or use of historic properties, if any such properties exist. The area of potential effect is influenced by the scale and nature of the undertaking and may be different for different kinds of effects cause[d] by the undertaking.” Included within the APE are all locations where the undertaking may result in ground disturbance (see Figure 2).

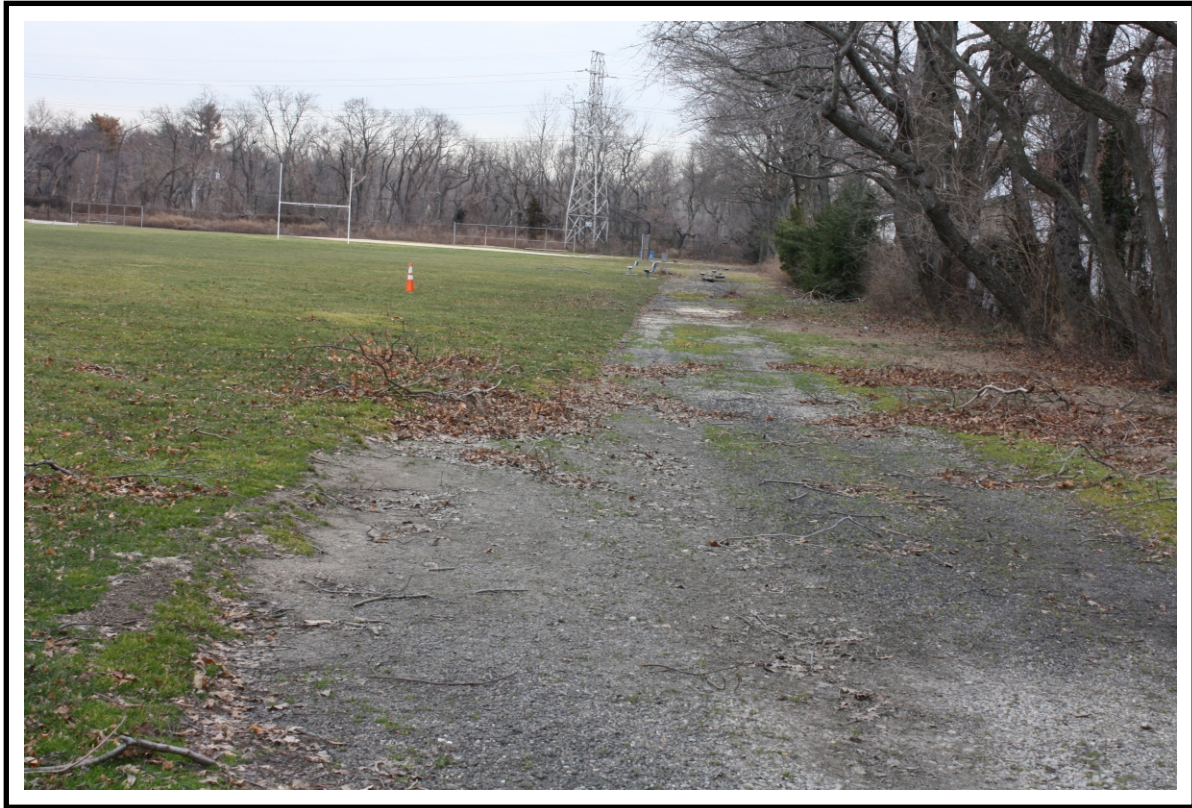
Photograph 2:

Unimproved roadway on the eastern edge of the ball field (Section D). STPs 6-17 were placed adjacent to this roadway in the grass field.

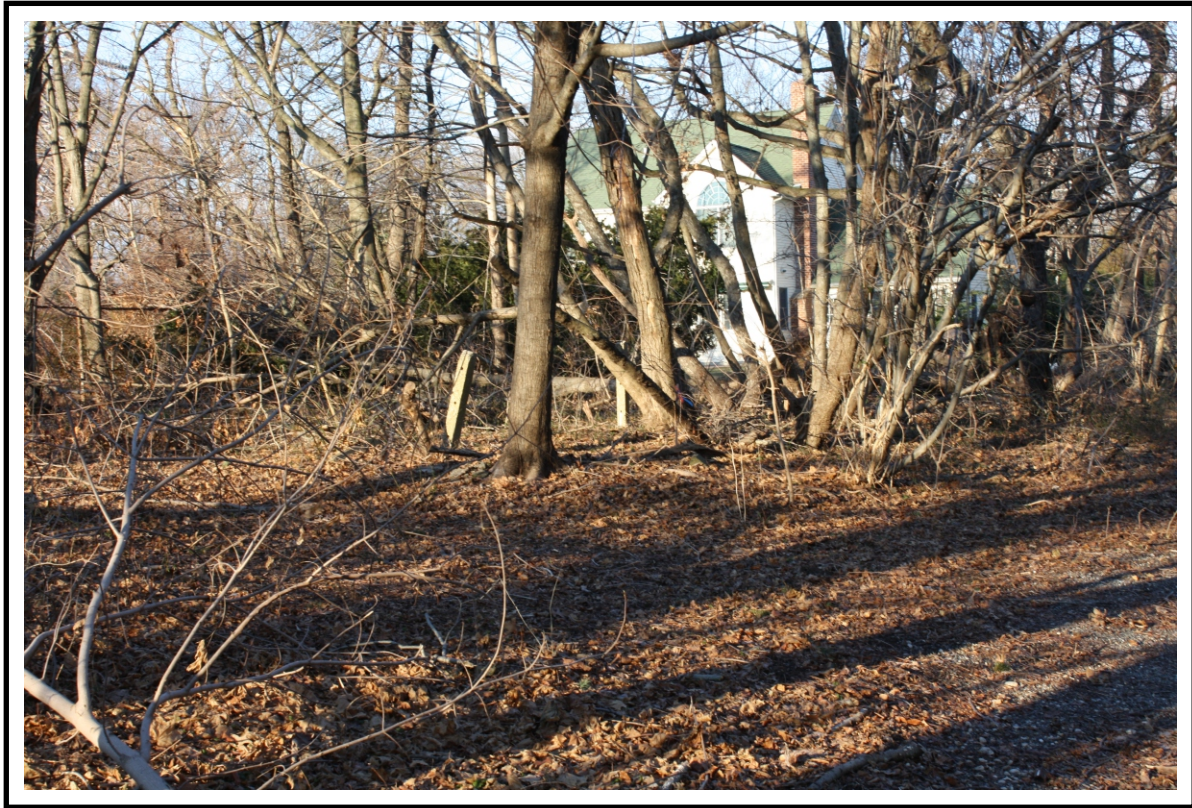
Photograph 7:

Portions of the Long Island Motor Parkway within the APE (Section E) showing remains of concrete guard rail posts near a modern house.

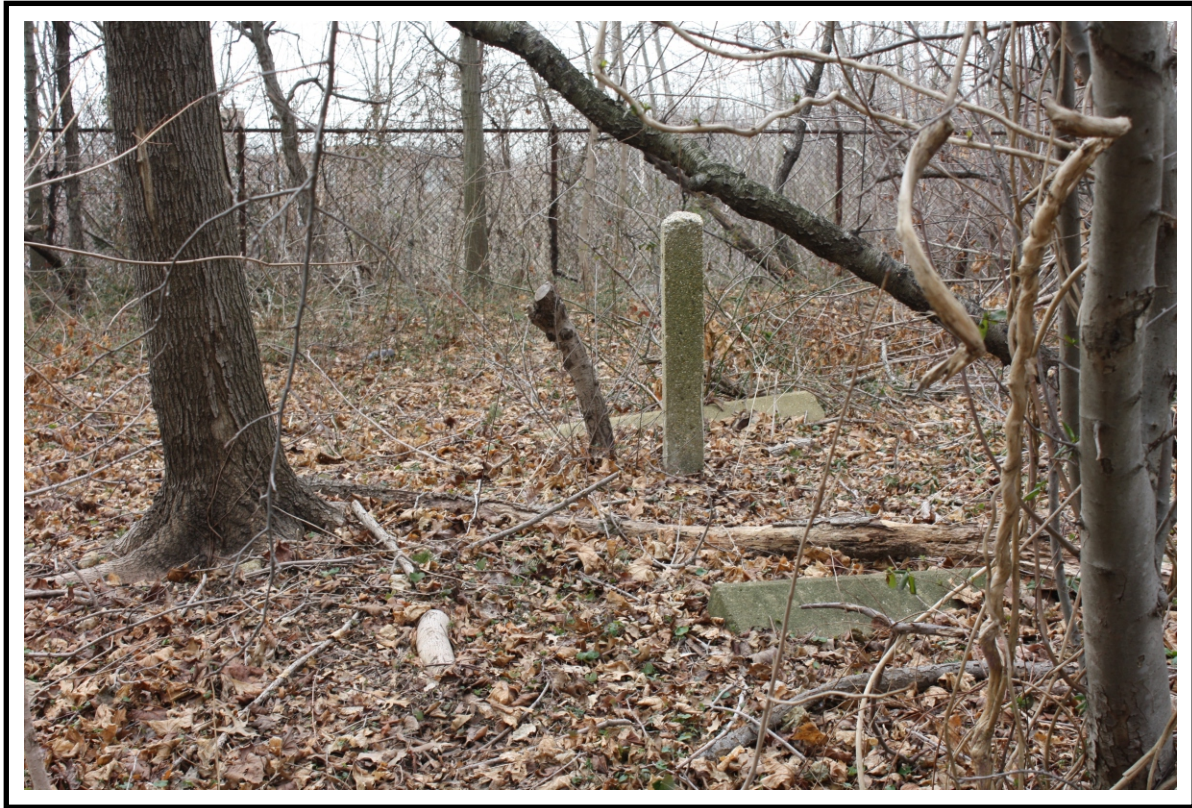
Photograph 8:

Portions of the Long Island Motor Parkway within the APE (Section E) showing remains of concrete guard rail posts and curbs.

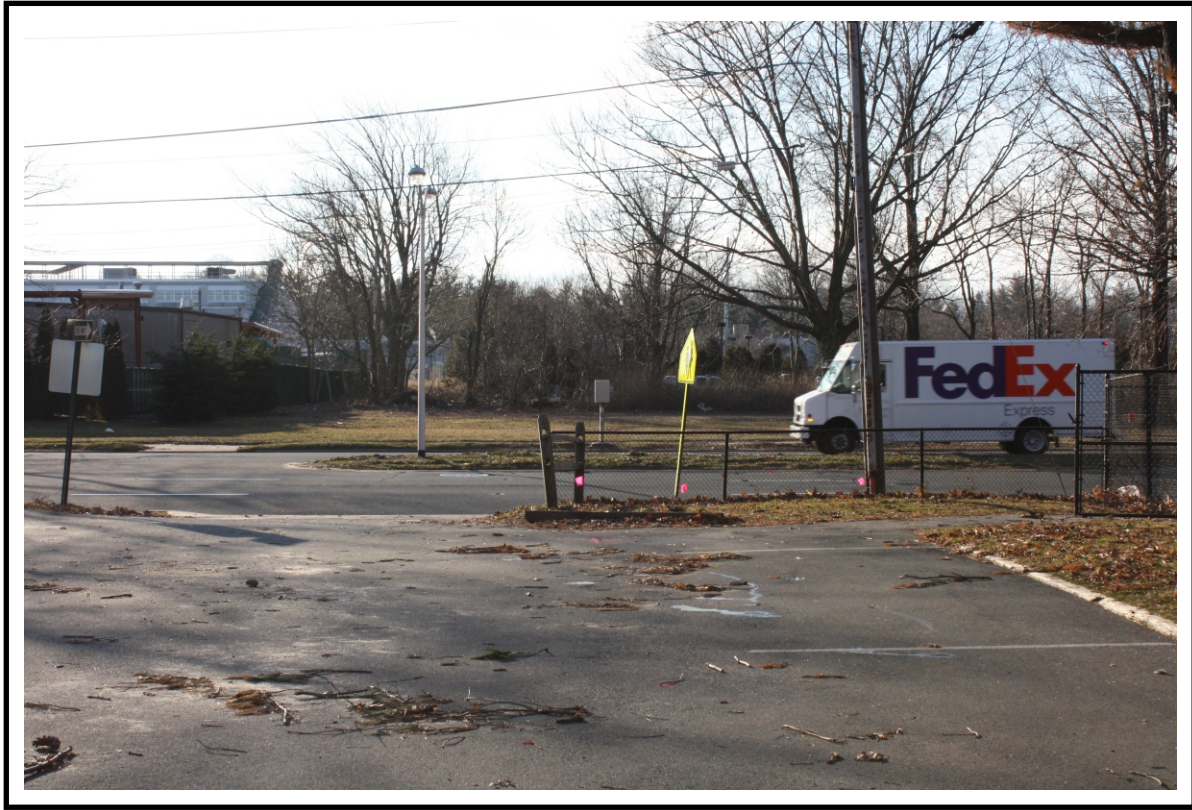
Photograph 13:

Portion of the APE that extends through the Stewart Elementary School ball field parking lot and across Stewart Avenue (Section B). Horizontal directional drilling is proposed to carry the pipeline across Stewart Avenue.

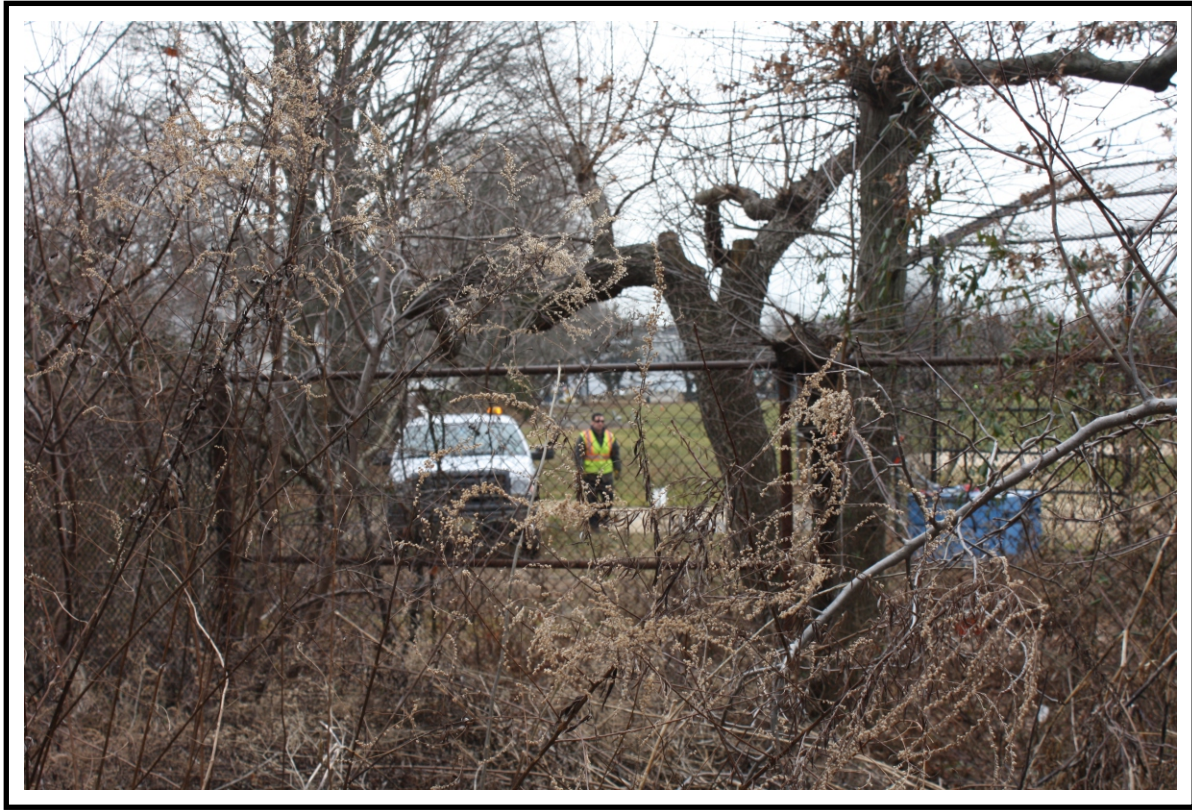
Photograph 17:

Northern end of Section D of the APE in the location of a fenced wooded area adjacent to the former Long Island Motor Parkway. Horizontal directional drilling is proposed to carry the pipeline through this area.

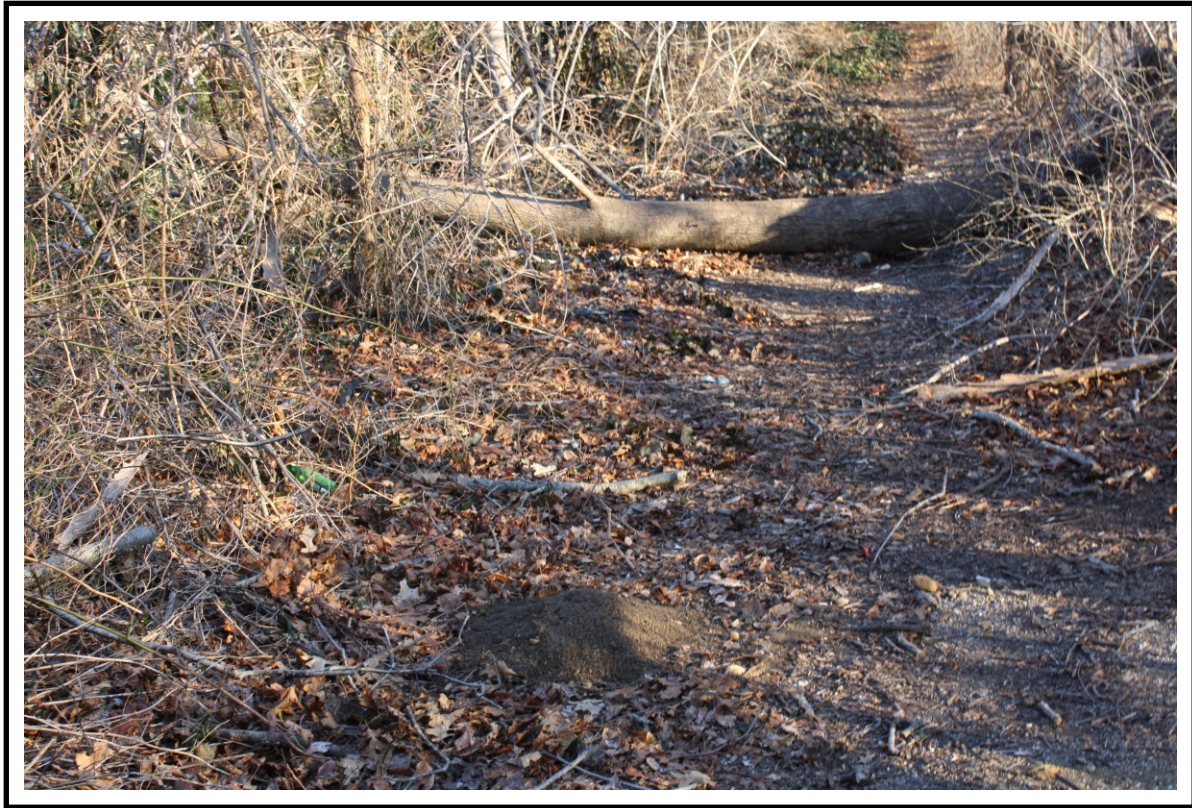
Photograph 18:

Section F of the APE adjacent to the eastern fence of the Garden City Pumping Station and the water tank where STPs 30 and 31 were placed. A large stormwater basin is located to the east.

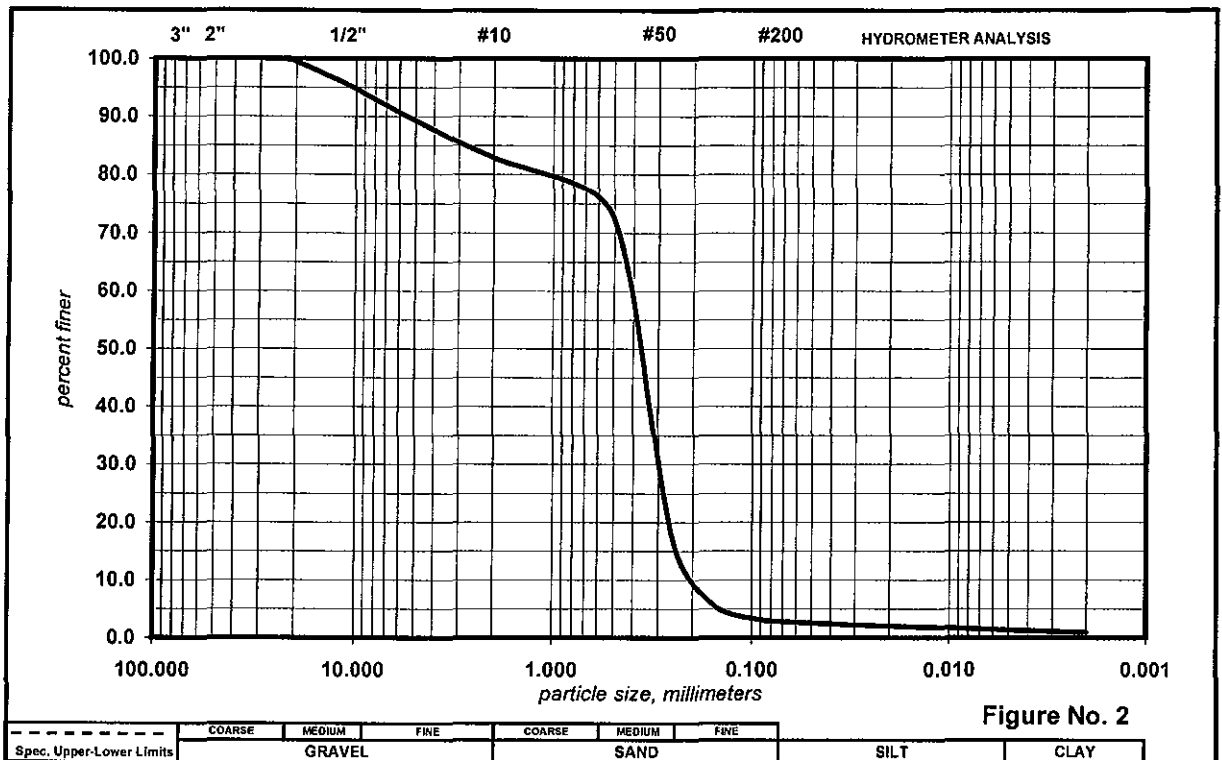
| Specification* | | | | Sample Identification | | |
|---|---|---|---|--|--|--|
| Sieve Size | % Finer | Min.(%) | Max.(%) | Sample No.: RB-1, S-2 Lab No.: A08-324-02 Source/Location: 10'-12' Description: Red. Yellow cf SAND, trace Silt, little mf Gravel <i>sample description in accordance with Burmister System</i> LL : PL : PI : As Received Moisture Content: 16.5 % Classification: USCS: [SP] AASHTO: Remarks: Sample received in lab on September 17, 2008 | | |

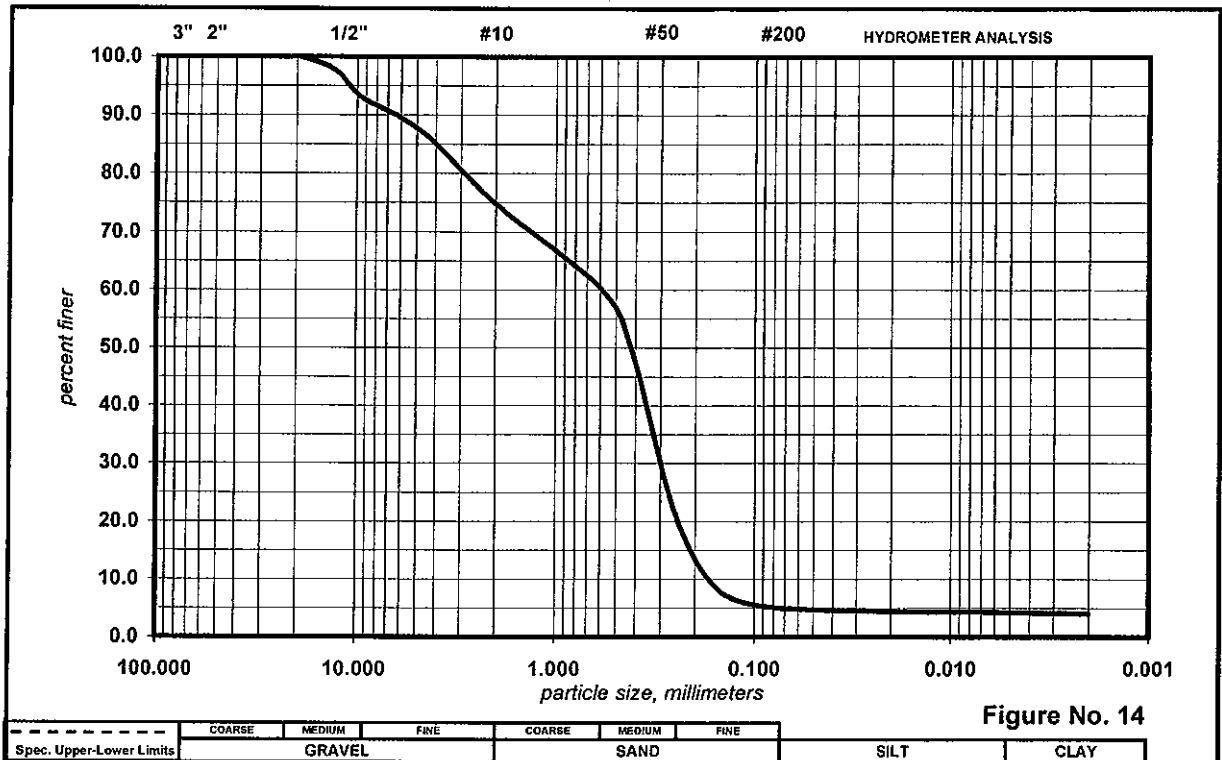
| Specification* | | | | Sample Identification | | |
|---|---|---|---|--|--|--|
| Sieve Size | % Finer | Min.(%) | Max.(%) | Sample No.: RB-2, S-7 Lab No.: A08-324-14 Source/Location: 35'-37' Description: Yellowish Brown of SAND, trace Silt, some mf Gravel <i>sample description in accordance with Burmister System</i> | | |

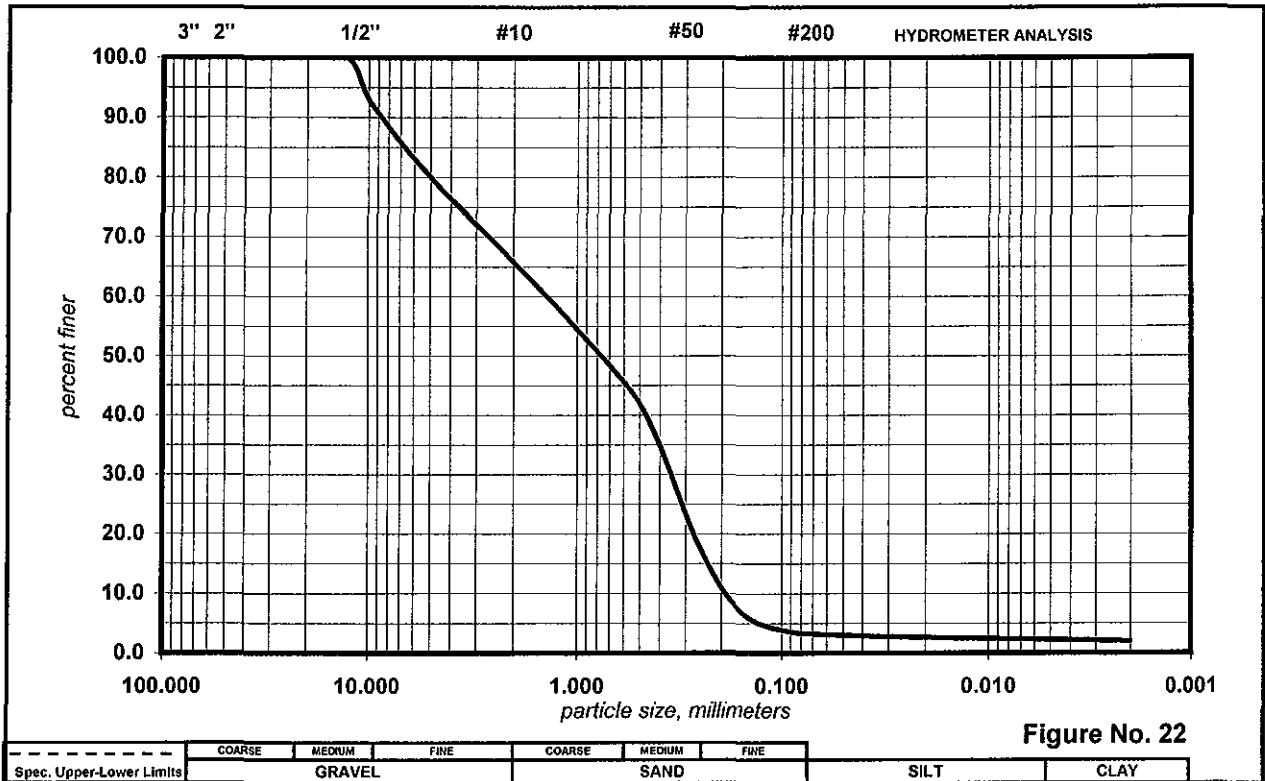
| Specification* | | | | Sample Identification | | |
|---|---|---|---|---|--|--|
| Sieve Size | % Finer | Min.(%) | Max.(%) | Sample No.: RB-4, S-1 Lab No.: A08-324-22 Source/Location: 5'-7' Description: Lt. Yel. Brown of SAND, trace Silt, some mf Gravel <i>sample description in accordance with Burmister System</i> | | |

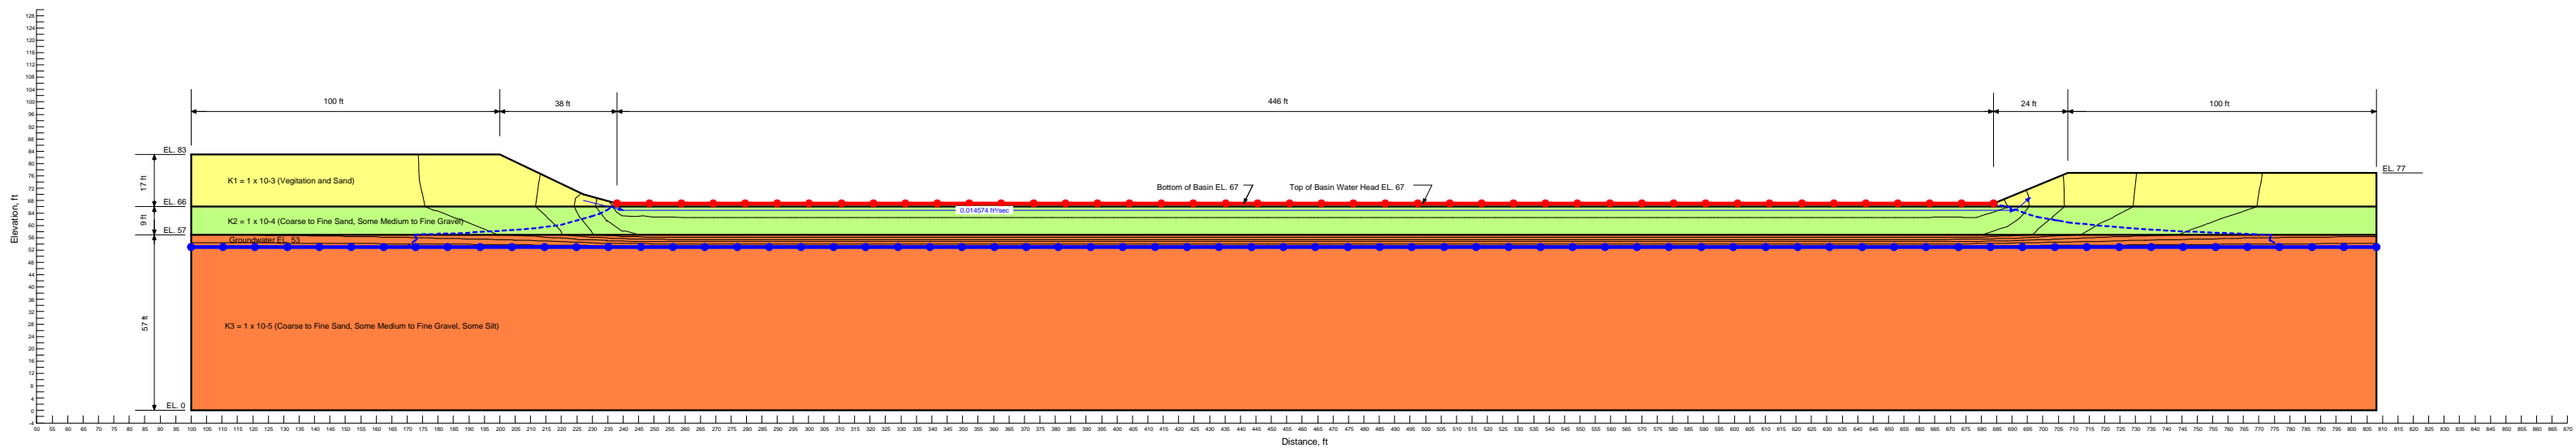
Roosevelt Field
Recharge Basin #124
Section A-A'
Basin Head = 0'

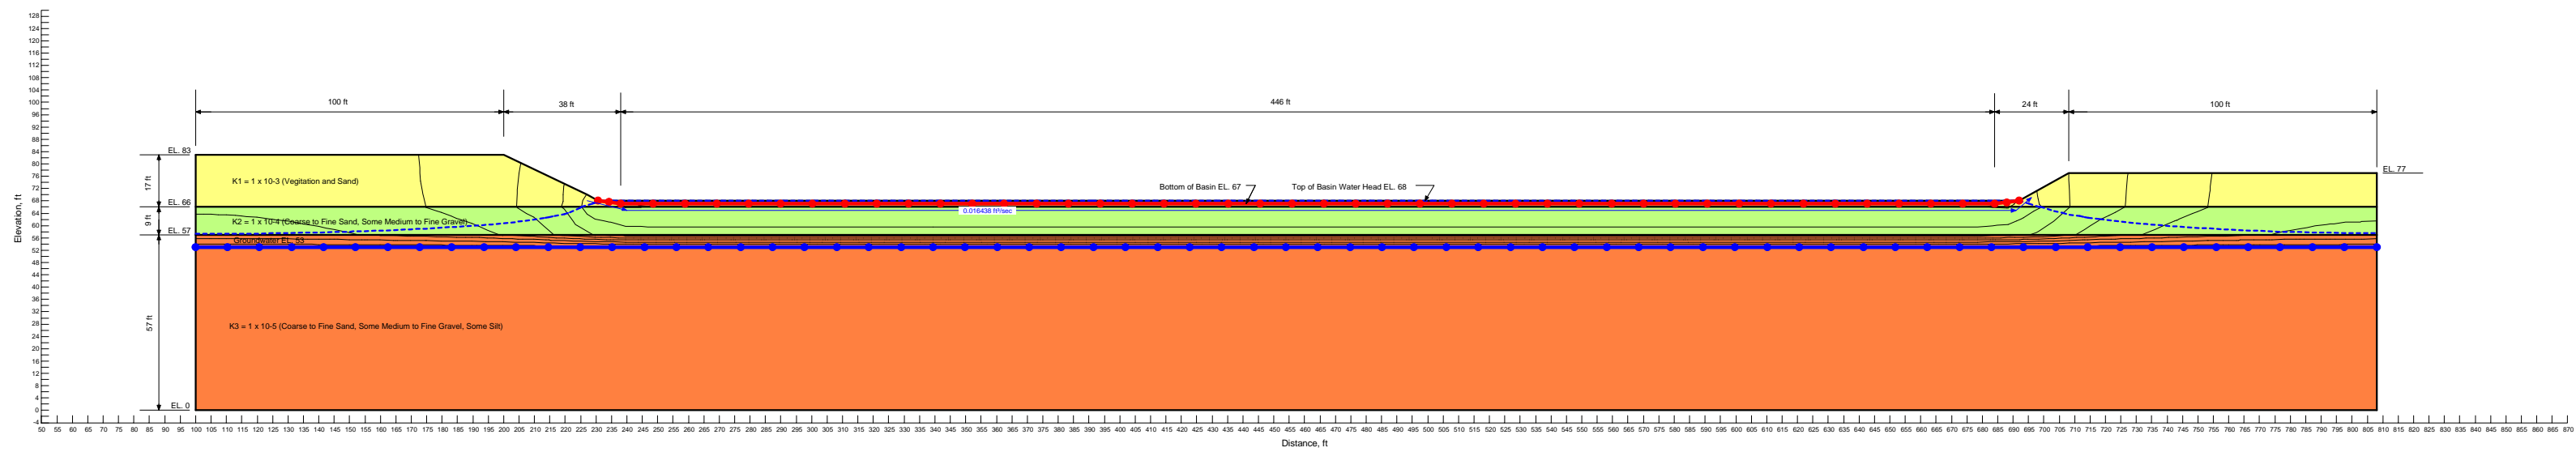
Roosevelt Field
Recharge Basin #124
Section A-A'
Basin Head = 1'

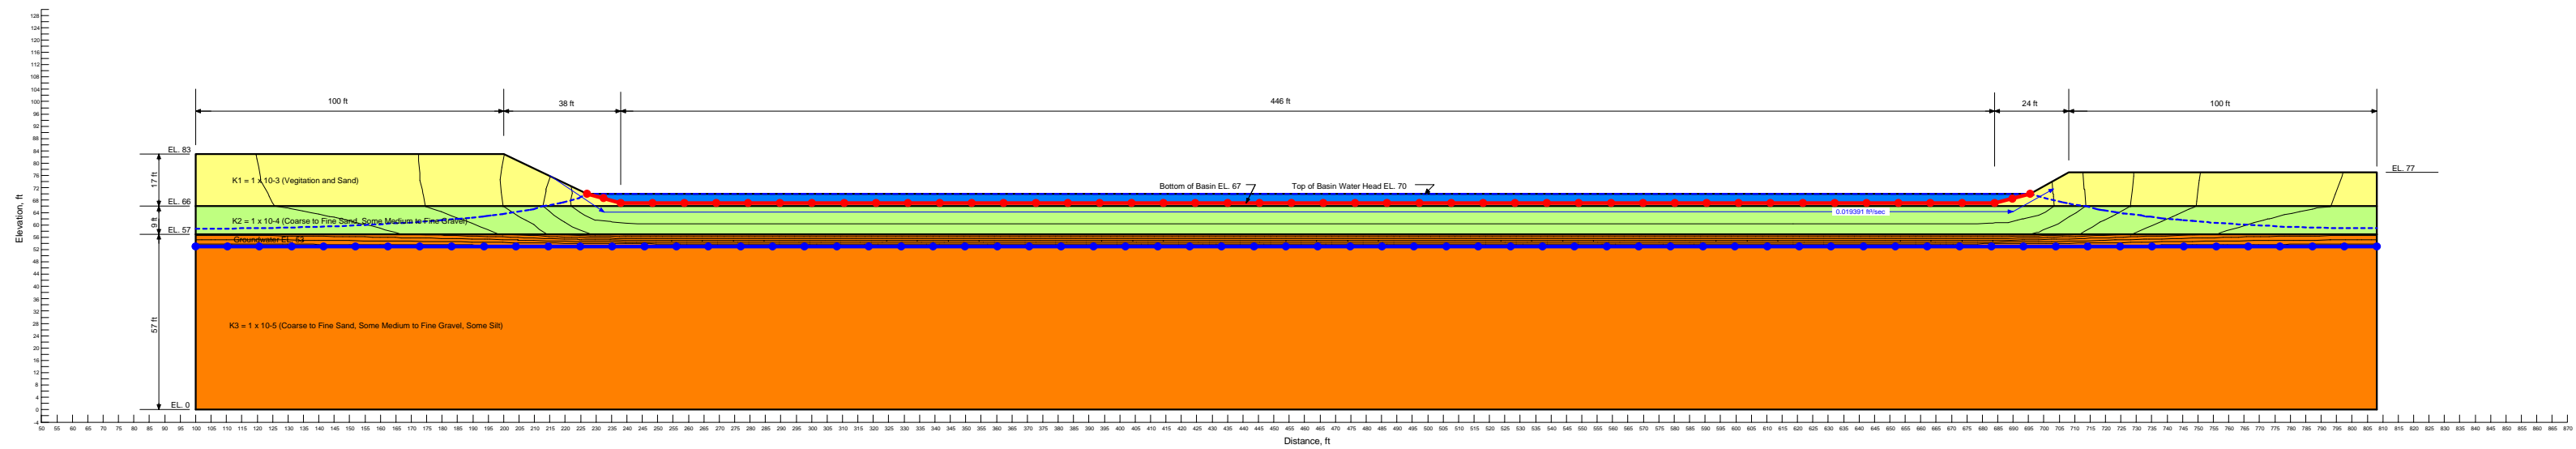
Roosevelt Field
Recharge Basin #124
Section A-A'
Basin Head = 3'

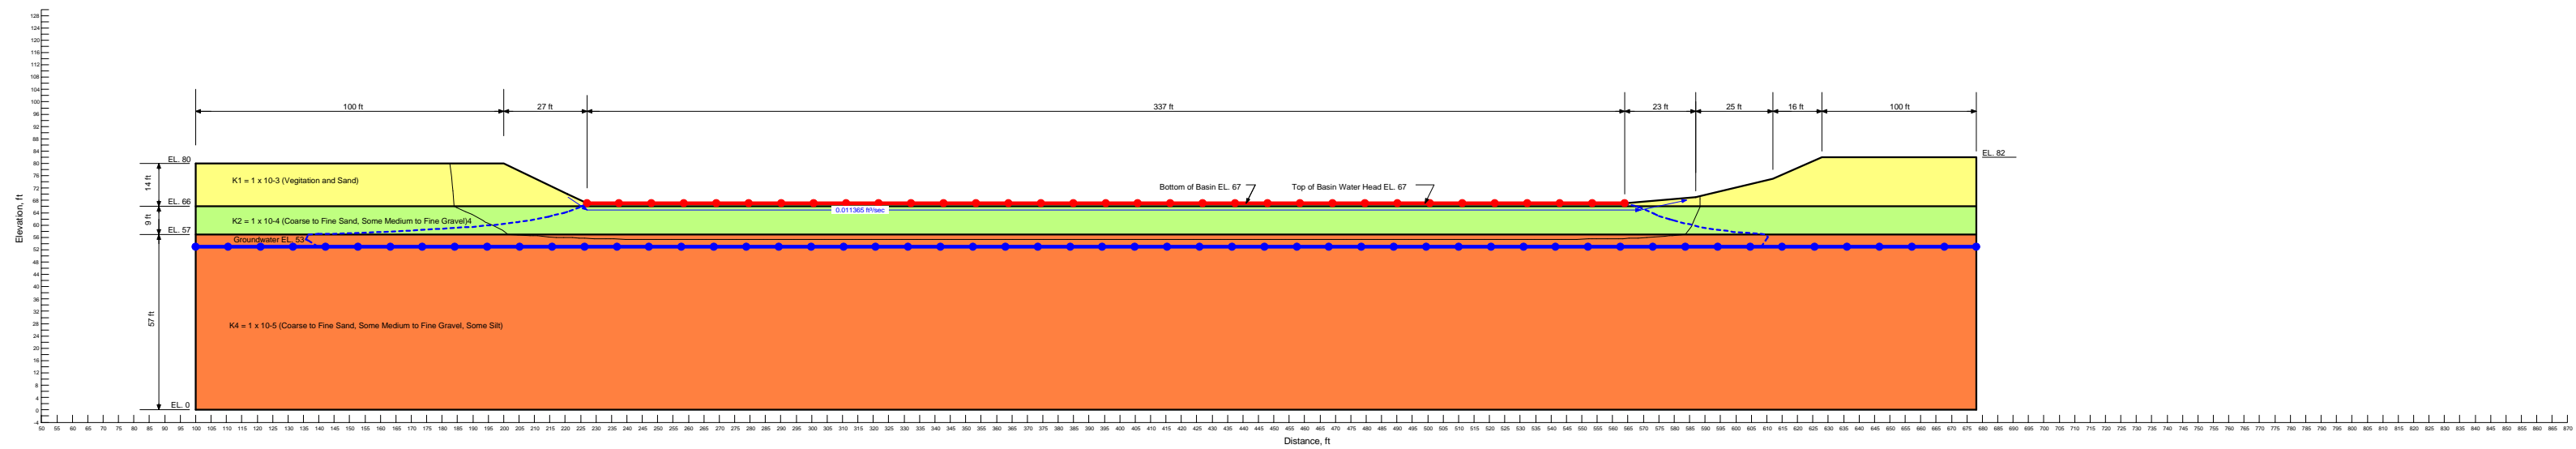
Roosevelt Field
Recharge Basin #124
Section B-B'
Basin Head = 0'

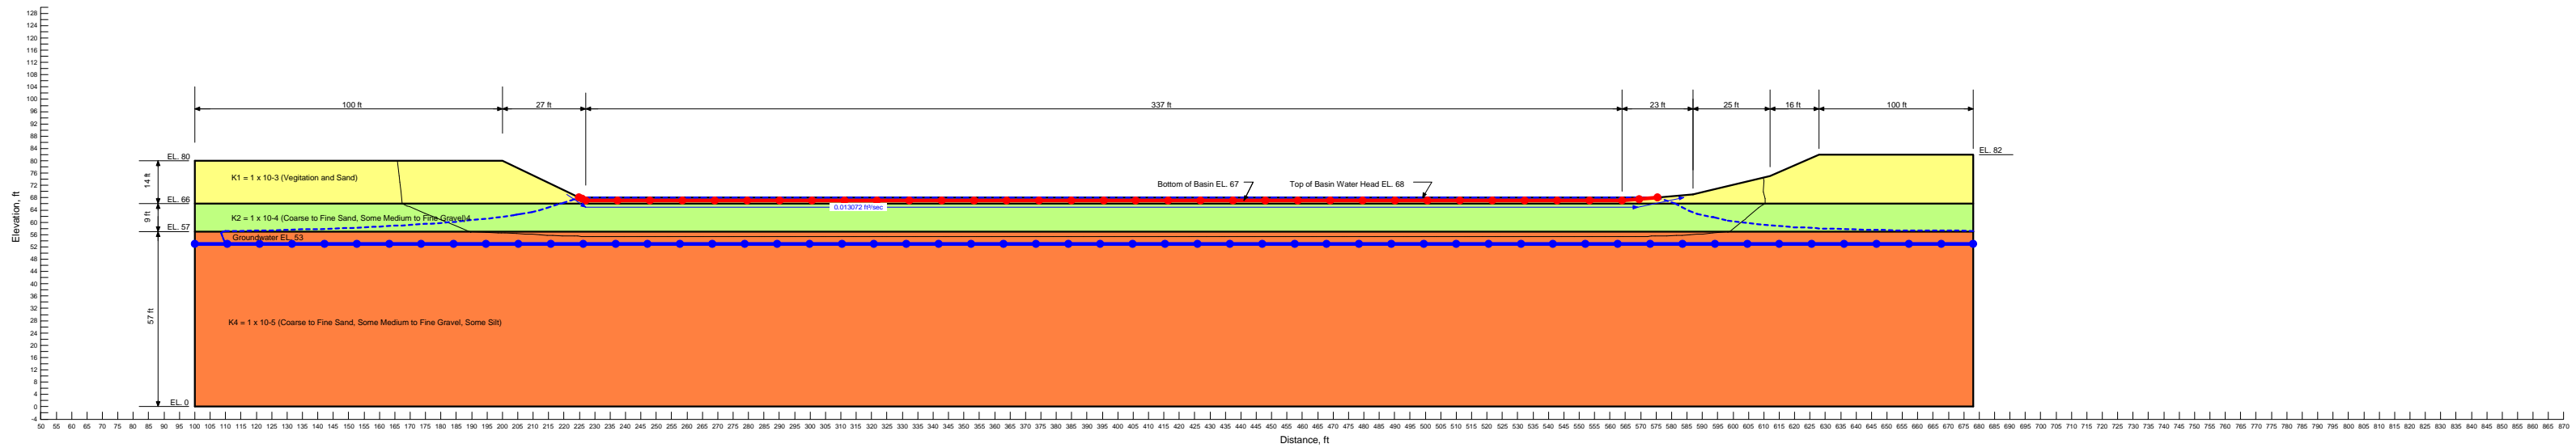
Roosevelt Field
Recharge Basin #124
Section B-B'
Basin Head = 1'

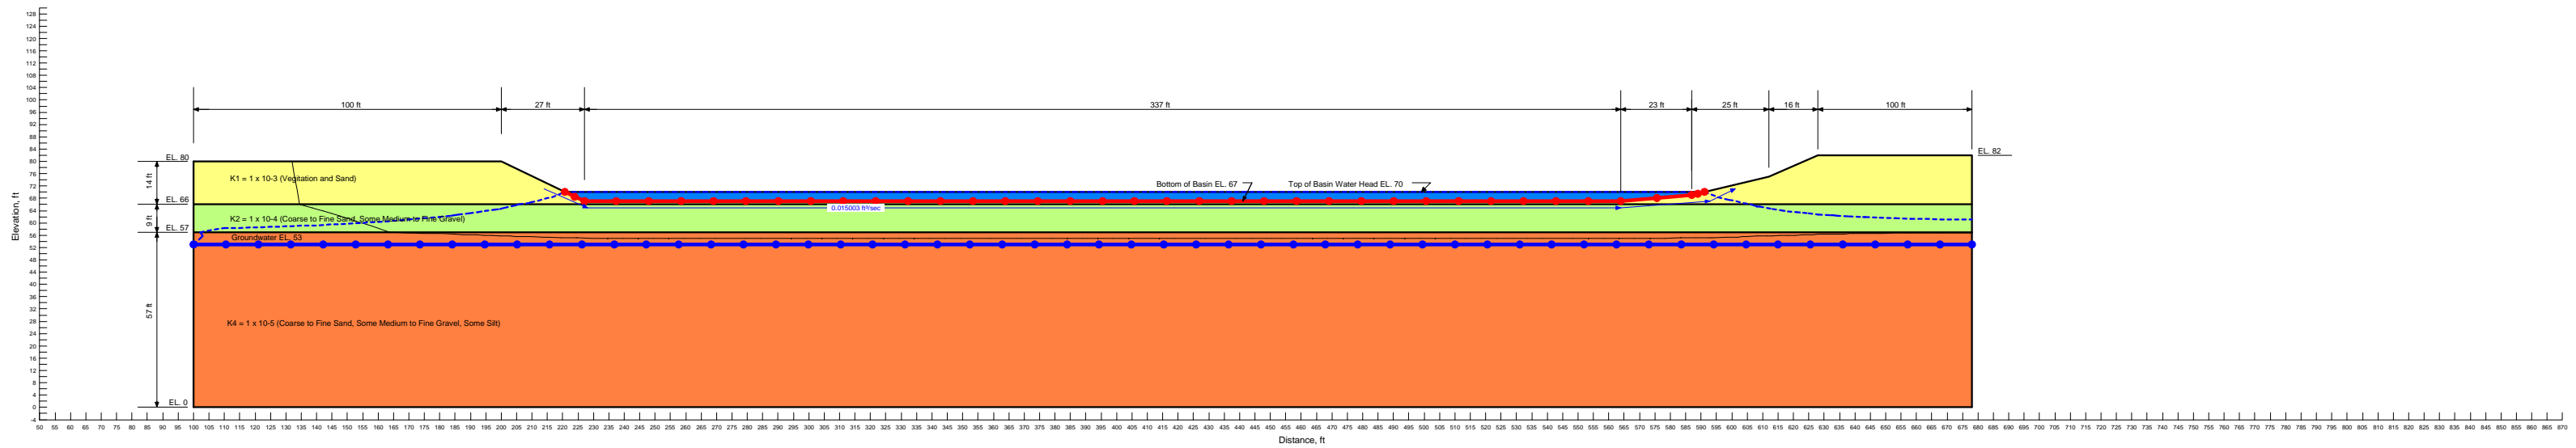
Roosevelt Field
Recharge Basin #124
Section B-B'
Basin Head = 3'

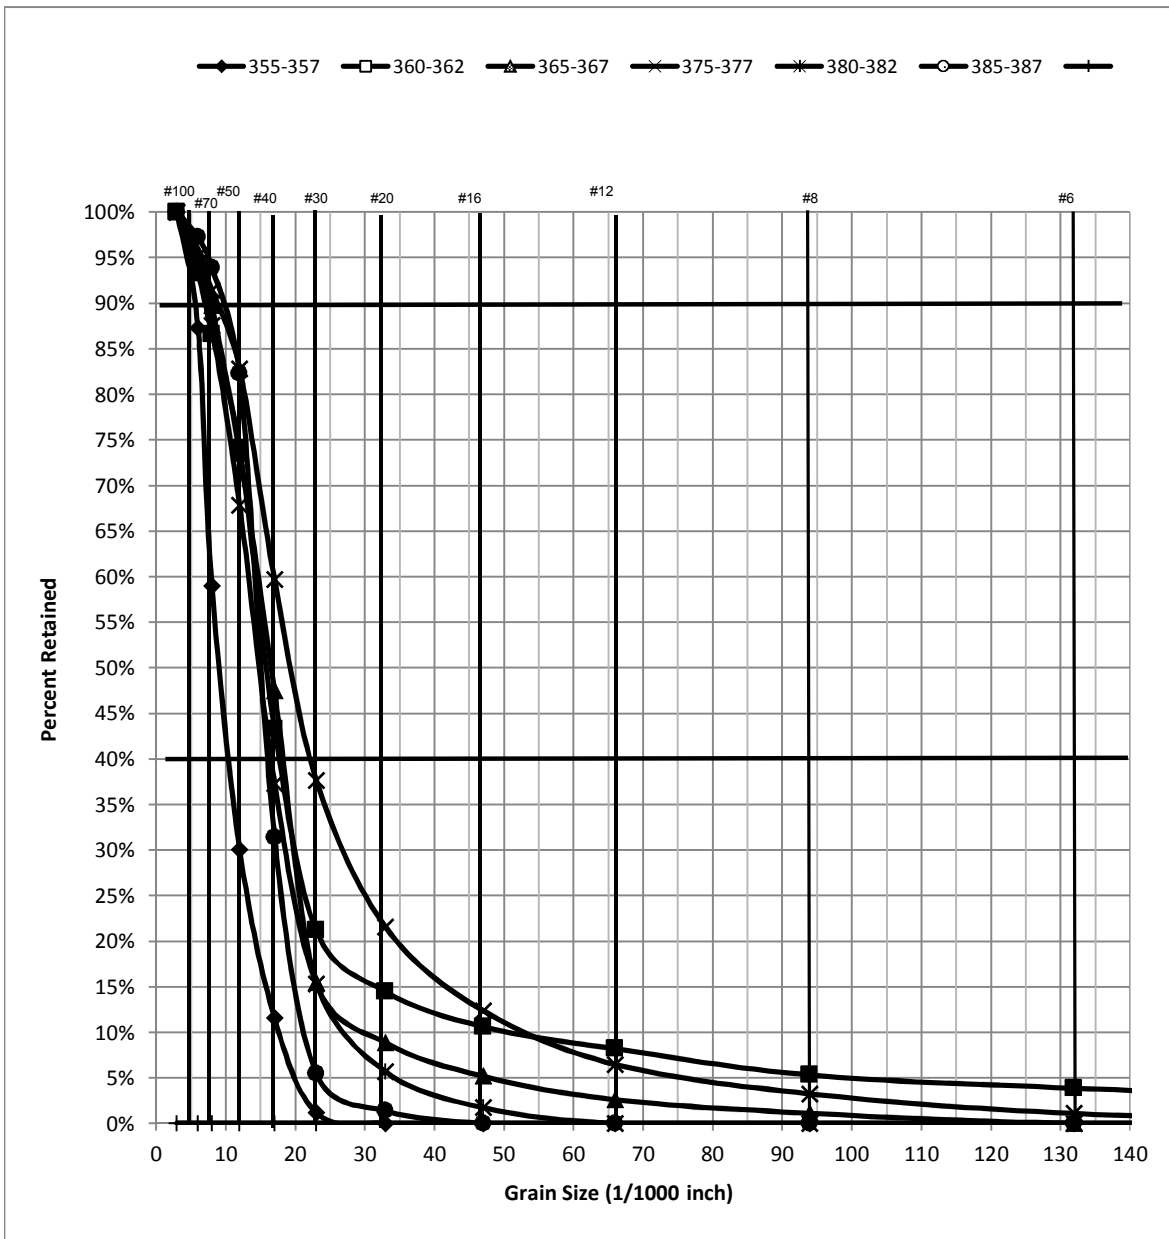
Job Name Old Roosevelt Extraction TB-1

Based exclusively on the samples provided by the contractor, a sieve analysis graph and suggested screen slot size is provided as requested. Since numerous construction considerations and site circumstances influence successful well completion, Johnson Screens assumes no responsibility for final well performance nor awareness of local regulations pertaining to well installations.
